Comparative Study of GFRP Rebar and Steel Rebar used in Concrete Sections

Abstract

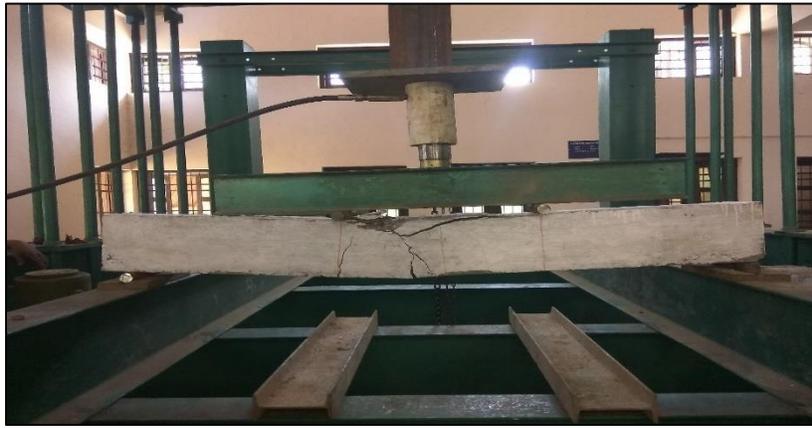
Fig. 5: Failure Pattern of Steel Reinforced Beam

In the initial stages of loading, for all the beams, cracks first appeared in the constant moment zone. As the load increased, additional cracks developed in the mid span and new vertical cracks formed in the shear span. Crack pattern observed in steel reinforced beam is tensile crack, in middle of the beam more tensile crack observed. Crushing of concrete take place at the top of the beam and at bottom layer of beam, yielding of steel rebar occurred. All the beams reinforced with the steel rebar failed in flexure at an ultimate load. The crack pattern of steel reinforced beam showed that the initial crack originated at the outermost fiber of the tension zone at mid span and propagated towards the center of the beam. First crack obtained at a load of 38.6KN.

- In the case of steel reinforced beam flexural failures occurs, that is crushing of concrete take place at the top of the beam and at bottom layer of beam, yielding of steel rebar occurred. In the case of GFRP reinforced beam shear failure occurred.

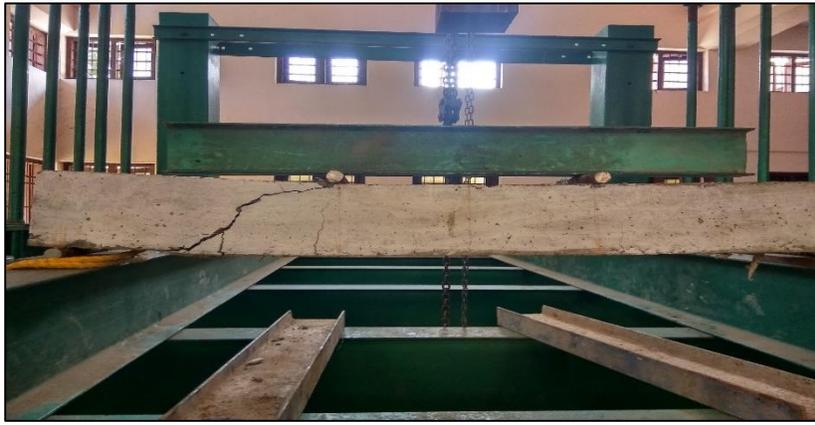
Fig. 6: Failure Pattern of GFRP Reinforced Beam

In the case of GFRP reinforced concrete beams, one of the vertical cracks in the shear span became critical and extended towards the loading point at the ultimate stage. The failure was observed to be mainly due to the slip of the rebar from the surrounding concrete. The slipping of rebar in GFRP reinforced beams was indicated by splitting of concrete at the level parallel to the reinforcements. Crack pattern mainly due to shear failure of beam, comparatively less number of middle crack was observed. Failure of GFRP reinforced beam mainly due to shear. The initial crack originated near the supports and propagated towards the loading points. First crack obtained at a load of 26.7KN.
