# Scour and Deposition around Causeways and Bed Bars

## Abstract

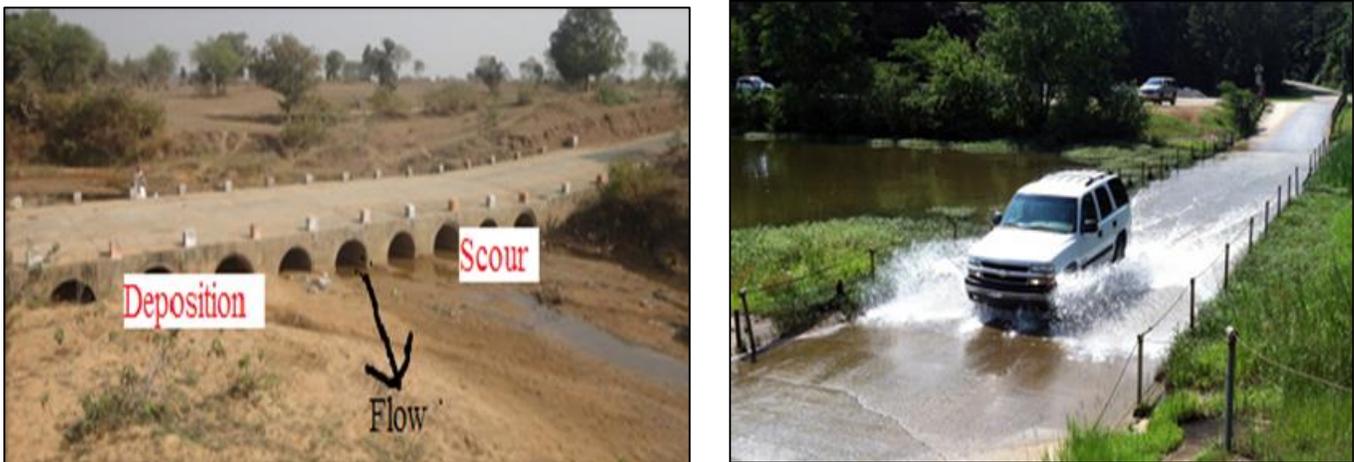
Fig. 1: Vented and Flushing causeways

The proper location of the causeway is an important issue. In no case the causeway should be located at those places where river has meandering patterns. During flood it may happen that due to secondary currents the water may scour the bed materials of rivers from convex side (outer bend of river) and may deposits on concave side (inner bend) resulting choking of many ducts (vents of causeway) as shown in Fig.1.

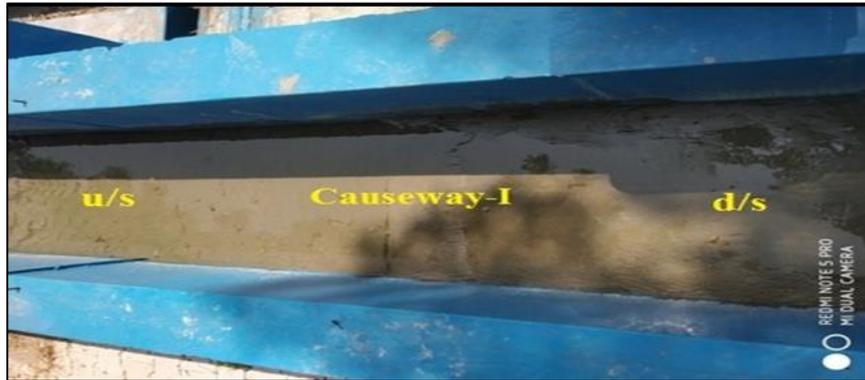
Fig. 6: Photogrammetric view of scour around Causeway I

The photogrammetric view of the scour at causeway-I is shown in Fig.6 and graphical representation in Fig.7. It is clear from this figure that at all discharge values, the scour around the edge of the first causeway placed in straight channel and normal to flow is almost uniform and with low magnitudes. This may be attributed to uniform velocity and pressure distribution near and upstream of the causeway. Very small ripples were seen at low value of discharge and moderate dunes at high value of Flow. The flow being subcritical and shear velocity is also less than critical shear velocity.

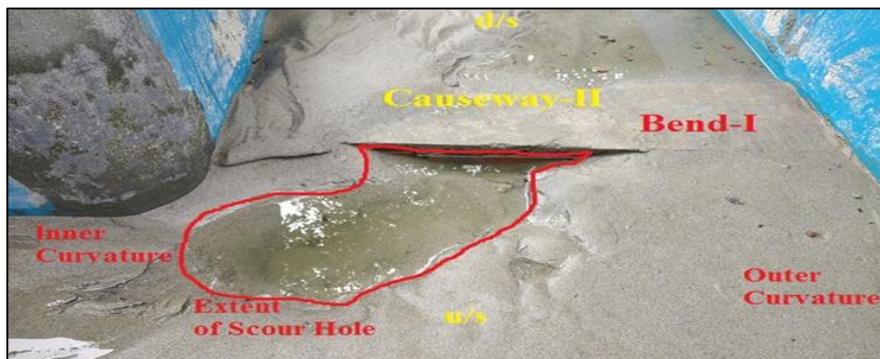
Fig. 8: Photogrammetric view of Scour around Causeway - II

Second causeway was located just downstream of the first bend to see the effect of the presence of bend on scour pattern. Since flow is not uniform at upstream of the causeways due to the presence of the bends, the scour and successive deposition which occur along the edges of the causeways is also not uniform. The scour starts to occur after one fourth length of the causeway and extends gradually towards the centre from left to right. At centre depth of scour is maximum. The scour hole and its extent can easily be seen in Fig.8 and Fig.9.

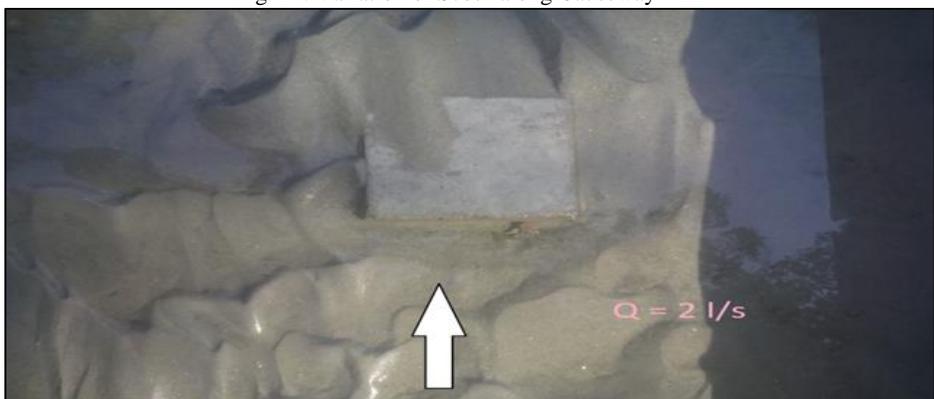
Fig. 12: Photogrammetric view of the Bed bar

For all four discharge values the scour depths were also measured around the bed bars and plotted as shown in Fig.12 and Fig.13.
